Manhole Inspection Summary

Manhole # S19I__007MH

Insp Date: **3/4/08 8:27 AM**

Location Address: **2109 baltimore st**

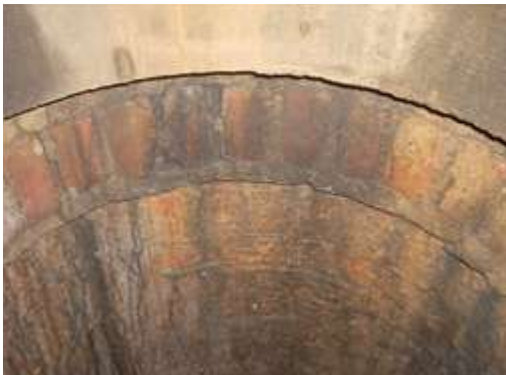
Defect 4

Infiltration: ☐ None ☒ **Joint** ☐ Cracks ☐ Mortar ☐ Roots ☐ Wall

infiltration evidence at the chimney joint

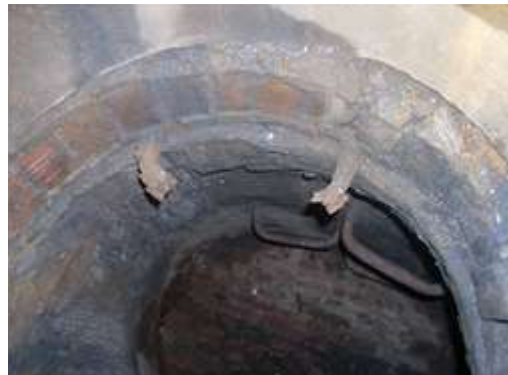
Defect 3

Count: **3** Missing: **1** ☒ **Corroded**

missing step

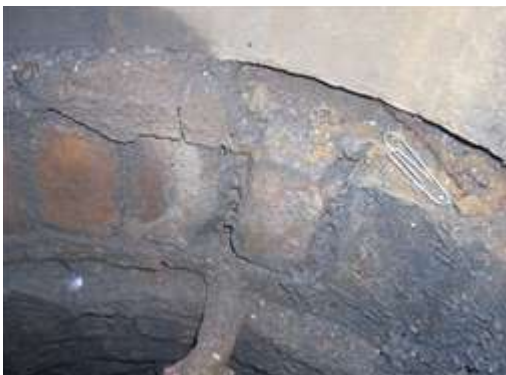
Defect 2

Condition: ☐ Sound ☐ Cracked ☐ Root Intrusion ☐ Loose Brick ☒ **Deteriorated**

slightly deteriorated chimney

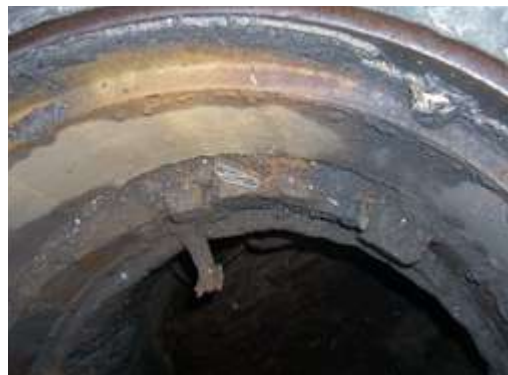
Defect 1

Offset: **3** (in.)

frame offset

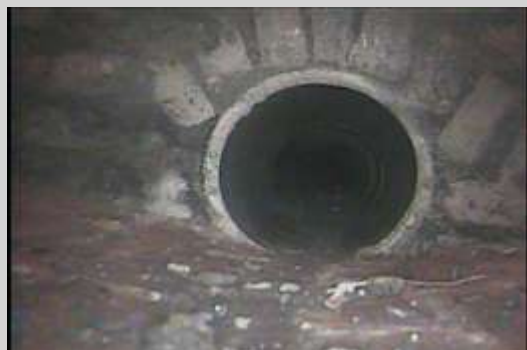
12 O'Clock Outflow

8 in. Circular Gravity Sewer
Pipe Out @ 12 O'Clock

Deposits: ☒ None ☐ Mud ☐ Sludge ☐ Debris ☐ Grease

Infiltration: **None** Pipe Seal Cond: **Sound**
